ROCKER COVERS

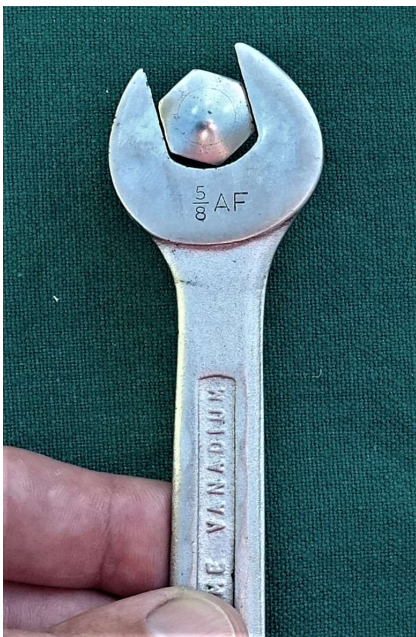
Rocker cover gaskets are stamped from a sheet of neocork, which is cork granules

bonded with a neoprene mixture and formed as a continuous sheet rather like a flexible equivalent of chipboard. It is the best material for the job, but unfortunately it doesn't age well. Replacement will be necessary after say, five years or so, regardless of mileage. Removal of the cover is achieved simply and quickly by undoing the two sleeve nuts on top. Their hexagons are shallow so the best tool is a flat spanner as in fig. 1; sockets and ring spanners have a chamfer which means that there is a lot less contact between spanner and nut. Standard spanner size for these sleeve nuts is 5/8" AF.

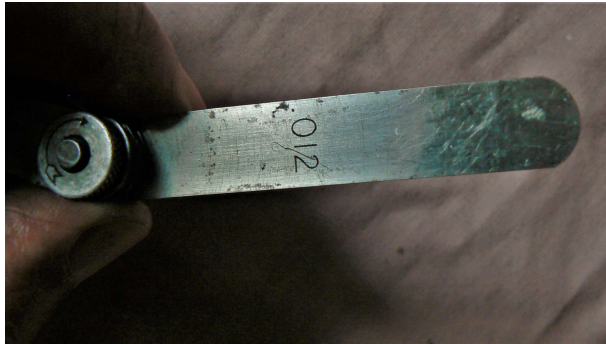
Whilst the cover is off, there's a good opportunity to check the valve clearances. It doesn't take long and is another ticked box on the maintenance schedule. It's a simple job which most will be familiar with. The etching on feeler gauges is notoriously hard to read (and to photograph)

see fig. 2, so make doubly sure you have the right one, .012". If you only have metric feelers, use 0.3mm. Use the starting handle to turn the engine or engage top gear and gently rock the car backwards to set the correct position for adjustment.

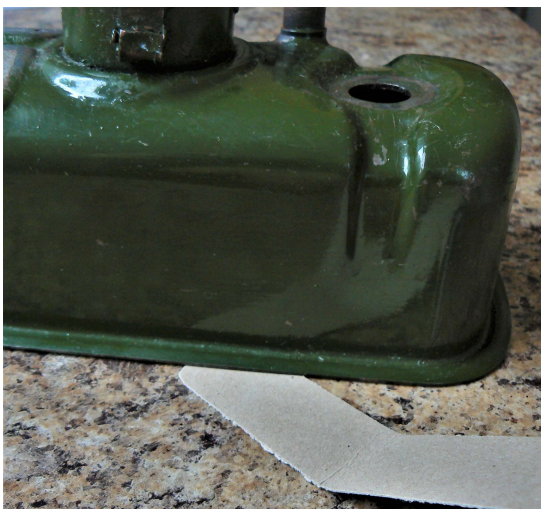
Observe in fig. 3 that two valves are depressed at any one time and the entire set can be checked/adjusted with only two revolutions of the engine.

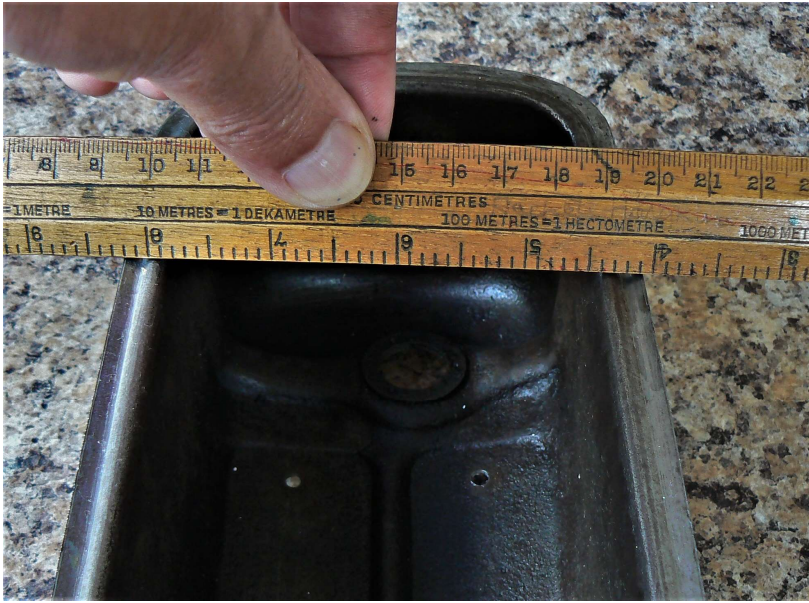
To ensure the best chance of a leak-free result, some care should be taken whilst refitting the rocker cover and its new gasket. First clean the cover scrupulously and examine it for distortion. The sides must be parallel with an even flange all round (fig. 4). Lay the cover on a good flat surface (a worktop is ideal as in fig. 5) and slip a piece of thin card under the edge to test the clearance. Small adjustments can be made by a little

judicious bending; using a hammer will in all probability make things worse! If overtightening has occurred, the area around the securing bolt holes will be distorted and must be brought back to be flat and even to give the sealing rubbers a chance to do their job properly.

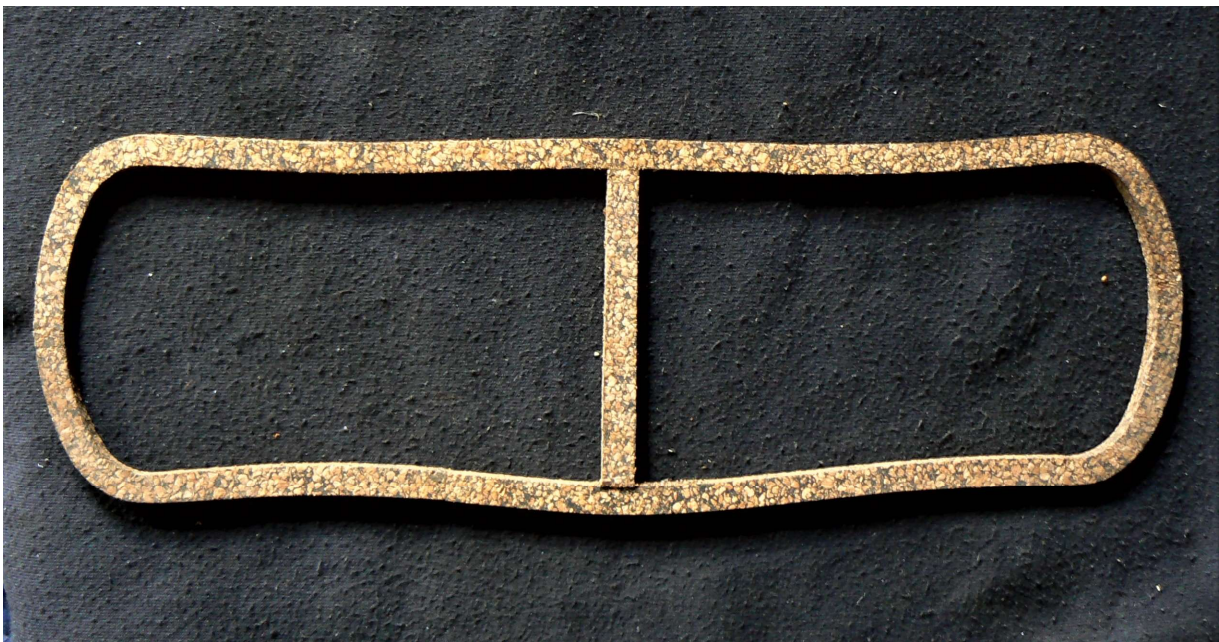
New gaskets, however carefully packed will have some degree of distortion as in fig. 6.

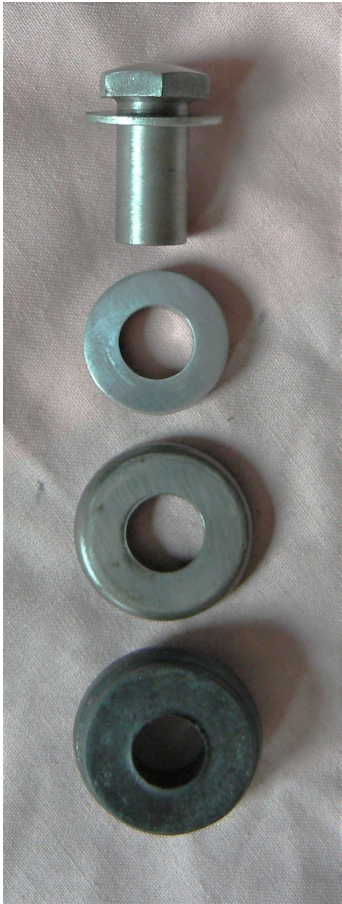
Sometimes there are lifting eyes fitted under these sleeve nuts, if not there should be a 3/16" spacer. Omission of either will prevent the cover being tightened down properly. The correct order of parts is shown in fig. 8 and is: 'rubber' oil seal, dished washer, spacer or lifting eye, thin washer, sleeve nut. Sometimes the dished washers

have gone missing and should be replaced, as they help to prevent the rubbers

spreading.

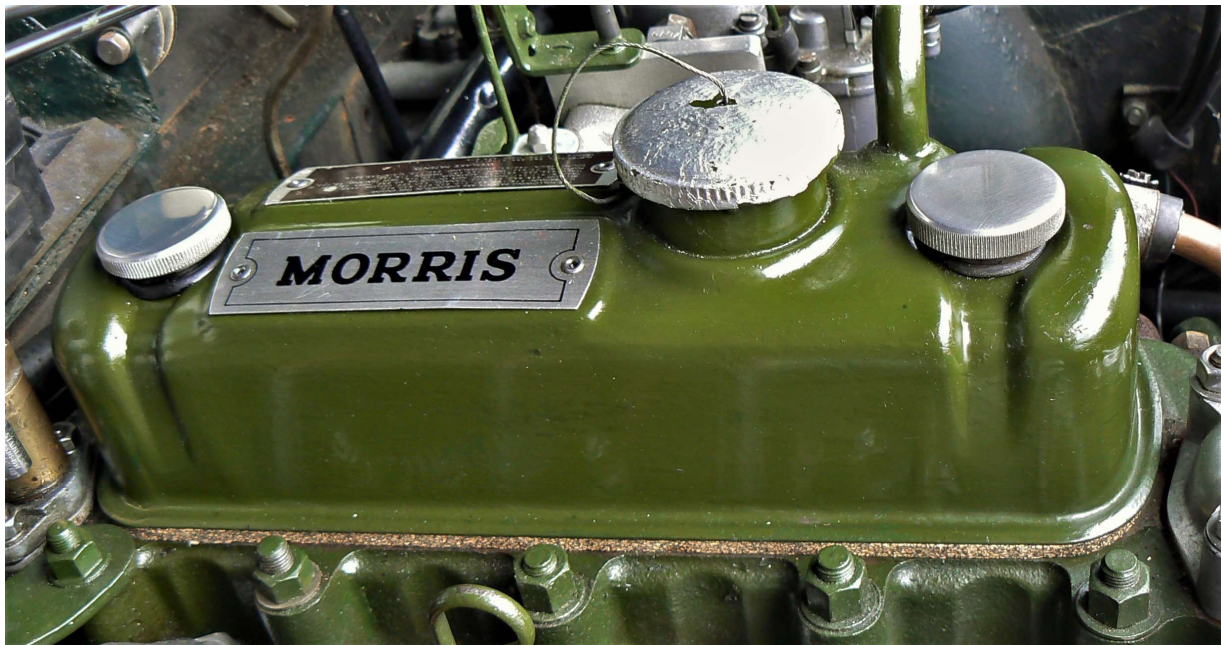
There is no need to get carried away when tightening the sleeve nuts, it only squashes the oil seal rubbers. Fig. 9 shows that the standard sleeve nuts have been replaced by some home-made items tightened by the fingers only, which is sufficient. The same illustration shows a new rocker cover gasket fitted evenly along its joint.
