Indicator Stalk Repair Instructions (for part number SWT101K)

Application: Later Minors (March 1959 onwards)

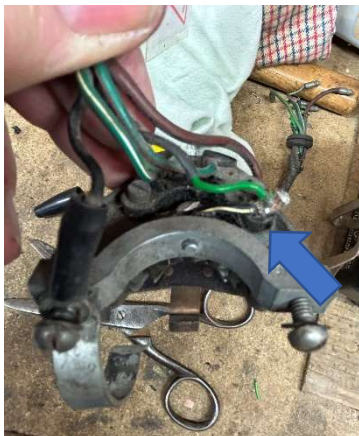
1. Carefully remove the centre horn push – gently levering around the perimeter.
2. Undo the centre steering wheel nut but do not remove prior to loosening the steering wheel on its splines.
3. Run the nut off the column and remove the wheel noting the alignment (for refitting).
4. Remove the three Phillips head screws which secure the black switch cover to the column.
5. Ease the cover upwards and remove.
6. Disconnect the bullet connectors and separate the indicator sub-loom from the main loom.
7. Undo the two machine screws which hold the clamp securing the switch to the column and note the position of the self-cancelling nipple on the column in relation to the two pawls on the switch itself.

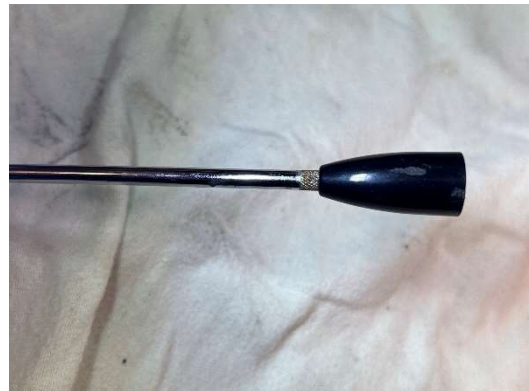
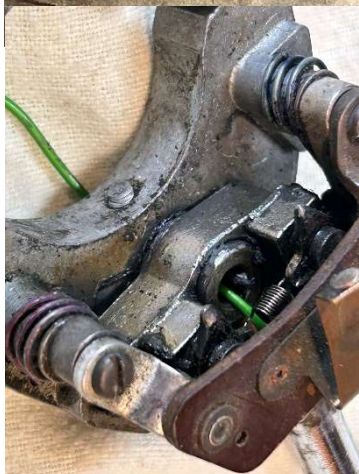
The black and white wire on the stalk which feeds the repeater lamp will need to be carefully de-soldered from the relevant terminal under the switch. At this stage you can remove the remains of the original cover (being careful not to damage the thin metal lamp holder and spring. The lamp holder and spring with the black and white wire attached can now be pulled clear of the stalk.

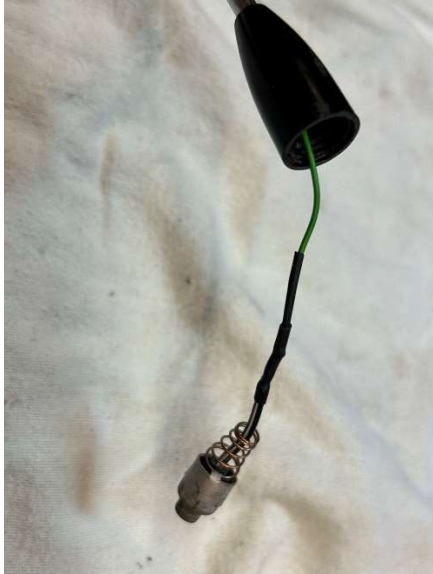
The black and white wire can now be re-inserted into the hollow stalk and the end passed through the pivot hole in the switch as before. If you feel it is now too short it can be replaced with new (preferably 'thin-wall' type wire) with

slightly more length as has been done in the photograph with a green wire. Re-solder the wire to the terminal all as it was originally. The metal bulb-holder and spring should now be securely seated within the new cover and the lamp and green hemispherical lens can now be replaced.

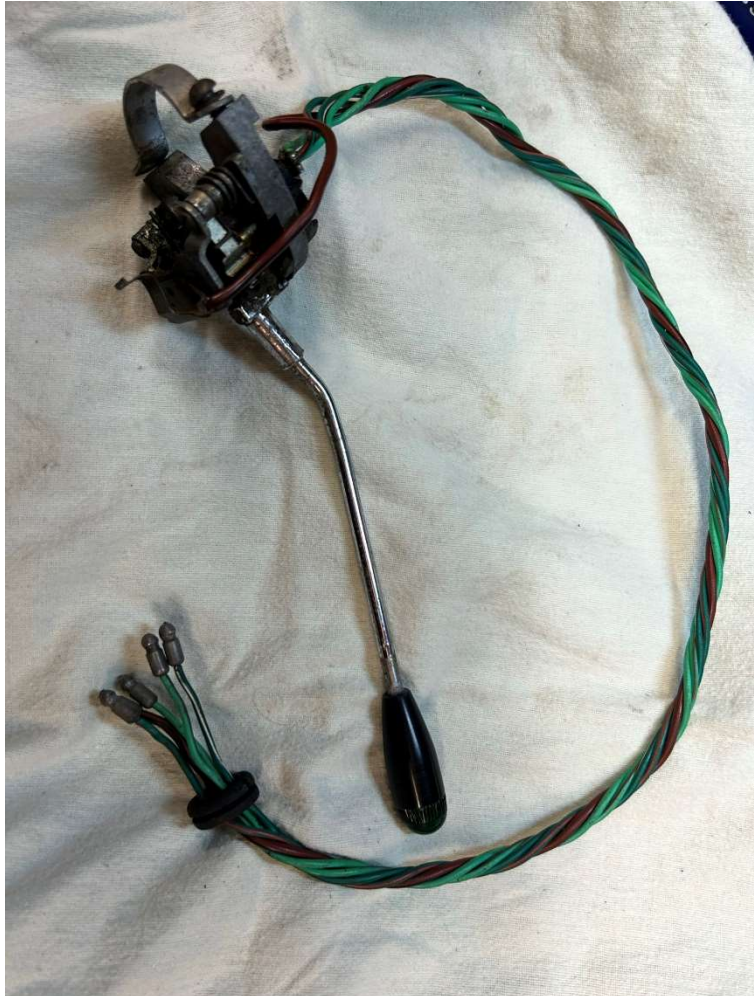
The green lens (SWT105) and lamp (BLB280) can be replaced if necessary.
